STUDY ON BEHAVIOR OF AMBIENT HYDRAULIC CYCLING TEST FOR 70 MPA TYPE-3 HYDROGEN COMPOSITE CYLINDER

CHO, SUNG MIN¹, KIM, CHANGJONG², KIM, EUNJUNG³ and KIM, INCHAN⁴

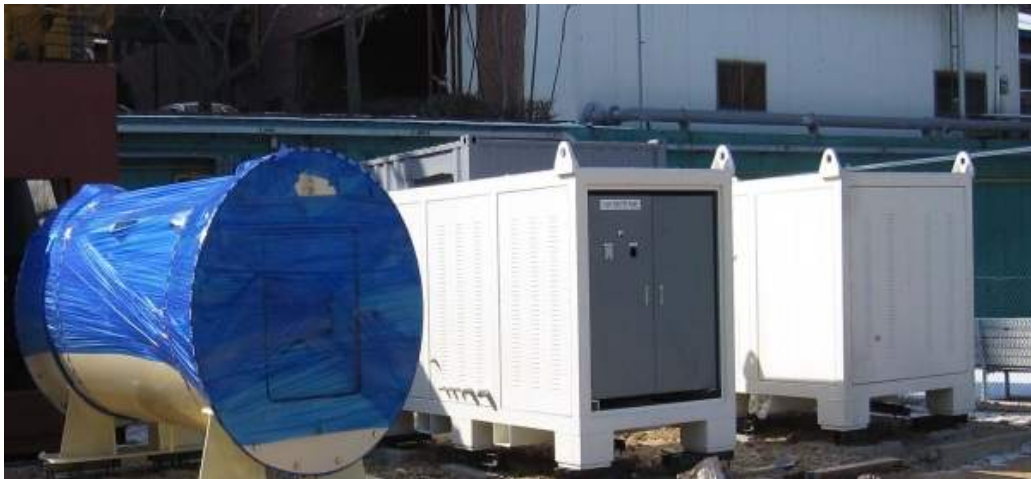
Figure 1. High Pressure Pump and Chamber

Today, since hydrogen cylinder is charged to 35 MPa and 70 MPa for use, the equipment dedicated to each kind of cylinders which have different performance and capacity is furnished at Korea Gas Safety Corporation for hydraulic cycling test. There is the equipment which can adjust the velocity per minute to the average of 6 cycles so that the time spent on tests can be reduced and there are other apparatuses each of which has its own pressure to match each demanded velocity per minute.

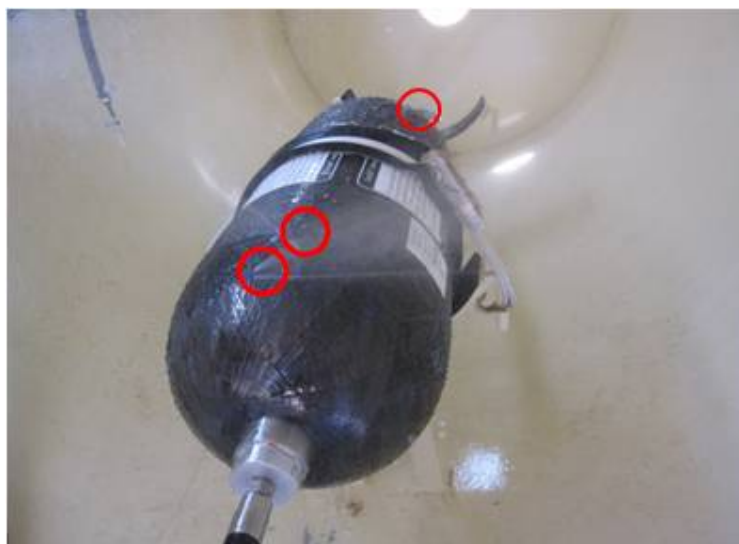
Figure 3. Leakage of Type -3 Cylinder

The picture below is about the hydraulic cycling test of foreign-made 40-liter 70 MPa. In general, the composite made of a bundle of fiber is solidified into resin, and if it has no sealing, the fluid inside, on being pressurized, is leaked to outside through small holes. The leakage to outside at the final stage when the liner comes to have internal cracks due to fatigue after it has had more cycles than those guaranteed by the manufacturers. It is necessary to find out what part of the inside of the liner has the leakage which can be visible with that.

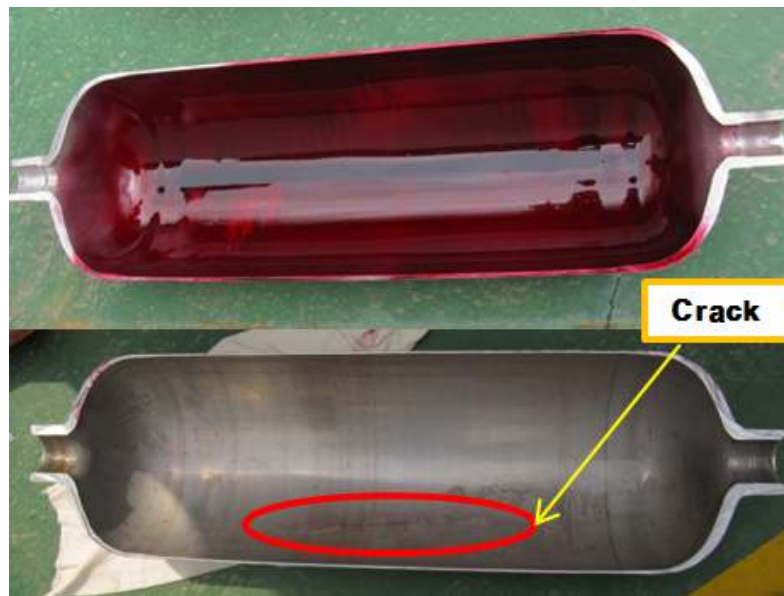
Figure 4. Penetration Test for Inner Liner of Type-3 Cylinder

A Penetration Test was carried out inside the liner with cut liner and composite material in order to find the exact position of the defected part in the cylinder which was found to have leakage by hydraulic cycling test, which showed long damage on the cylinder (body) as suggested at Fig. 4. What has to be noted at this point is that the leaking part on the liner was the center of cylinder while that of composite cylinder was dome knuckle and dome area, which can be thought as the following: the fluid did not leak directly into the top of composite material but to the part which is vulnerable to leakage (the parts of composite with the thinnest thickness or the area of insufficient impregnation).

- 2) In the case of leakage at the liner due to fatigue at Hydraulic Cycling Test of Composite Cylinder, the surface of the composite comes to have several areas of leaking. However, the Penetration Test revealed that the defect inside the liner occurs at the cylinder (body).

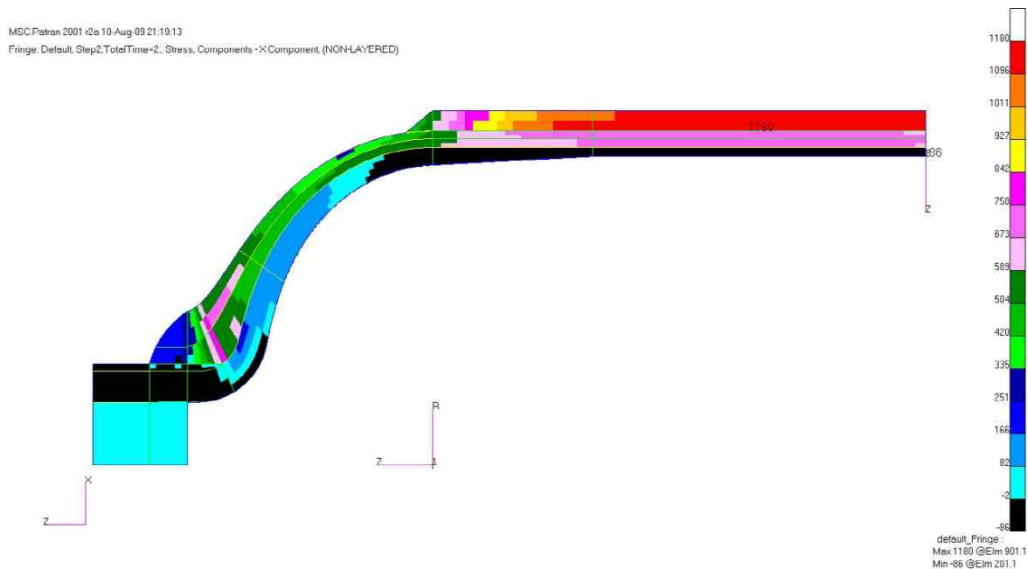
Figure 6. Stresses and Strains at Max. Fill Pressure

A variety of detailed structural analyses were carried out for the evaluation of the effect of such design variables as carbon fiber and liner shape on the structural behavior of cylinder along with the application of the above various analysis and design elements, which produced the below results as seen at Fig 6 through the examination of cylinder's structural behavior depending on the change of design variables.

For the structural analysis of composite pressure cylinder, the commercial software of MSC/PATRAN was used for 3-D modeling of liner, hoof layer and helical layer and then the stress and the deformation were analyzed by FEA commercial software of ABAQUS to show the stress and the deformation under the representative maximum charging pressure.

This shows that the composite cylinder has vertical motion around dome knuckle and that the parts of dome and boss horizontal motion. Accordingly, it was found that when pressurized, the cylinder (body) gets bigger stress than the dome area and gets swollen as being pressurized, which makes dome knuckle and cylinder (body) vulnerable to fatigue.

- 3) The Structural Analysis showed that the stress of cylinder is concentrated on the body. Accordingly, the deformation of cylinder shown by structural analysis revealed that the cylinder has vertical motion while the boss area horizontal motion. Consequently, it was found that when pressurized, the cylinder (body) gets bigger stress than the dome area does and gets swollen as being pressurized, which makes dome knuckle and cylinder (body) vulnerable to fatigue.
